Confidential Home Inspection Report

123 Main St
Tinton Falls, New Jersey 07724

Inspection Date:
Thursday, February 16, 2023

Prepared By:
Cole DeAngelis from Home Run Inspection Services

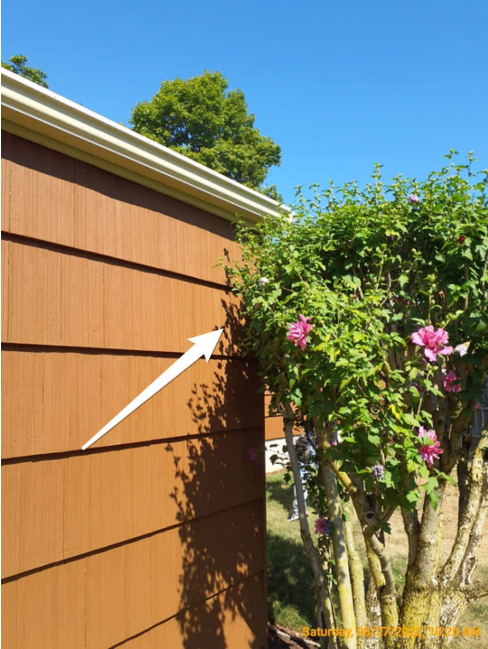
Vegetation

14: We recommend the vegetation on the property be maintained to prevent overgrowth and encroachment onto and over the structure. When vegetation is in contact with or too close to a structure, pests and moisture can quickly enter. It also limits the ability of the structure to effectively dry after rain. Structures that remain moist for prolonged amounts of time can have problems with rot, mold-like substances, and wood-destroying insects.

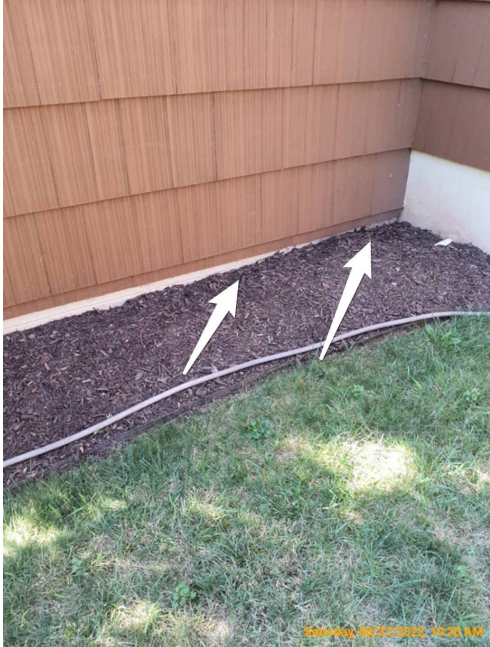
Wood Siding

15: There is potential earth-to-wood contact in one or more areas, which makes the siding vulnerable to deterioration. We recommend all earth-to-wood and near-earth-to-wood contacts be broken to prevent moisture or pest-related damage. It is recommended to have at least 8 inches of space between the wood siding and the earth to prevent moisture intrusion. This work should be performed by a qualified professional.

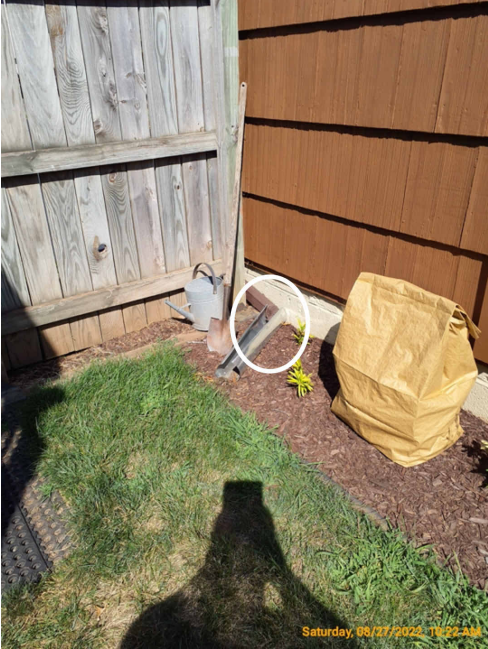
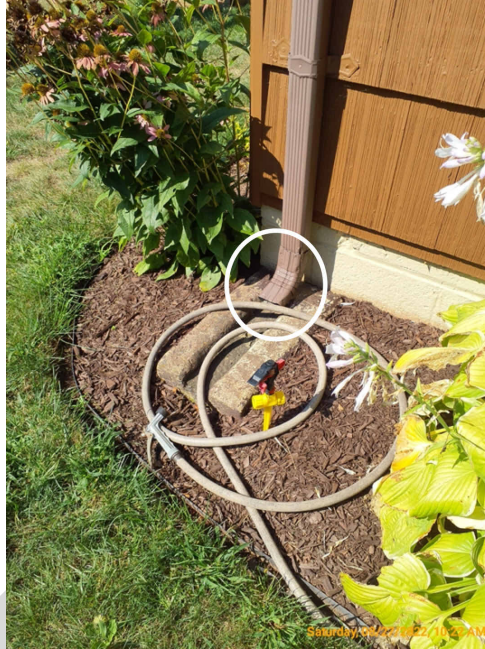
Downspouts

16: Runoff water from the roof appeared to discharge too close to the house in one or more areas. We recommend the downspouts discharge at least six feet away from the structure to prevent puddling, pooling, and over-saturation of the soil. If water discharges within six of a foundation it can cause structural damage, it can lead to a wet basement, and other issues. This should be corrected to avoid potentially costly damages.

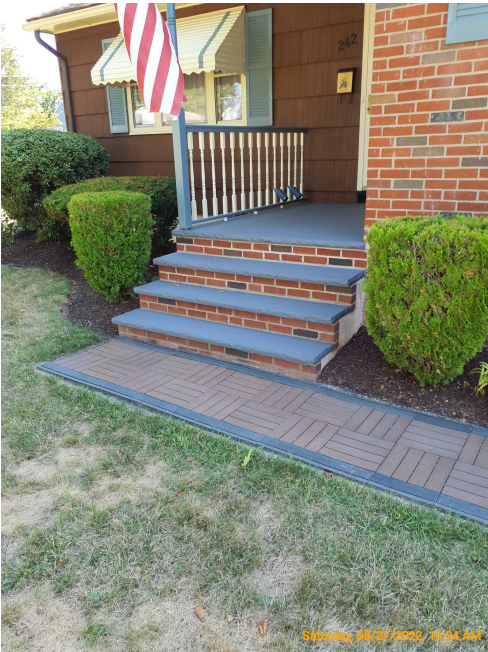
Railings

18: There are no hand railings at the front steps. As a safety measure, we recommend that railings be installed by a qualified professional. Without a sturdy railing to grasp in an emergency, a person could suffer bodily injury in the event of a fall or stumble.

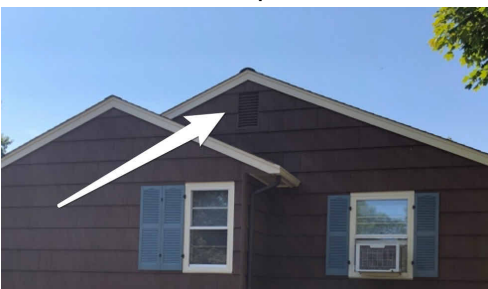
28: The main vents of the roof system appeared to be Ridge and Gable vents. There did not appear to be Soffit vents. We recommend adding soffit vents in order to facilitate better air circulation and ventilation of the Roof and Attic space.

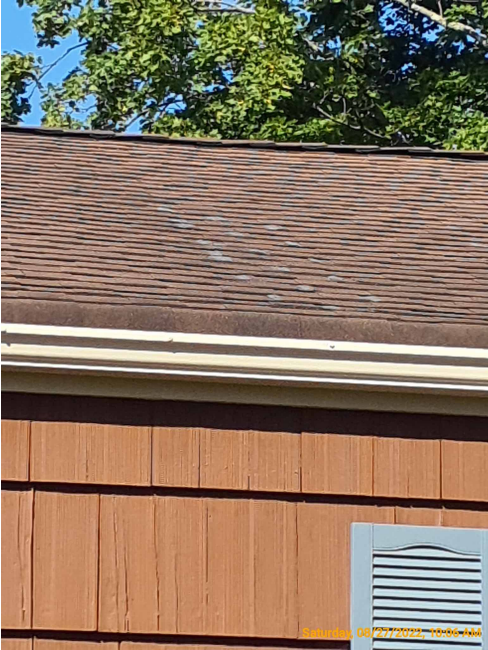
Surface

29: Portions of the surface granulation have deteriorated and there are areas of discoloration developing. These are signs of aging and the roof should be monitored to see if there is action warranted in the future to correct any problems. At the time of inspection, the roof covering did appear to be functioning even though there were signs of obvious aging.

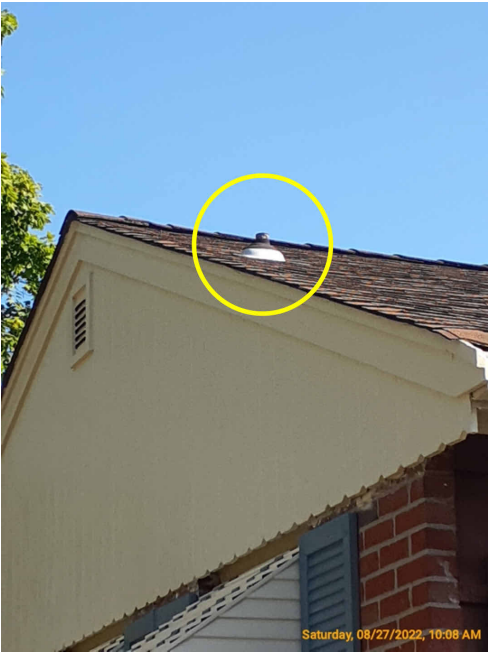
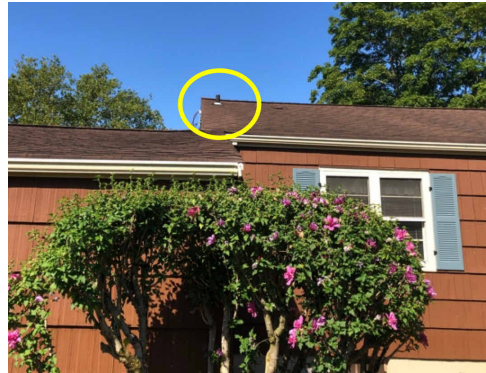
31: One or more of the plumbing vents is shorter than required by present standards. Poorly vented drain/sewer lines will not be able to effectively move wastewater and solids out. In our opinion, adverse conditions such as overflowing drains, backed-up toilets, and similar plumbing issues may result from this configuration. We recommend a qualified professional be hired to update to modern building standards.

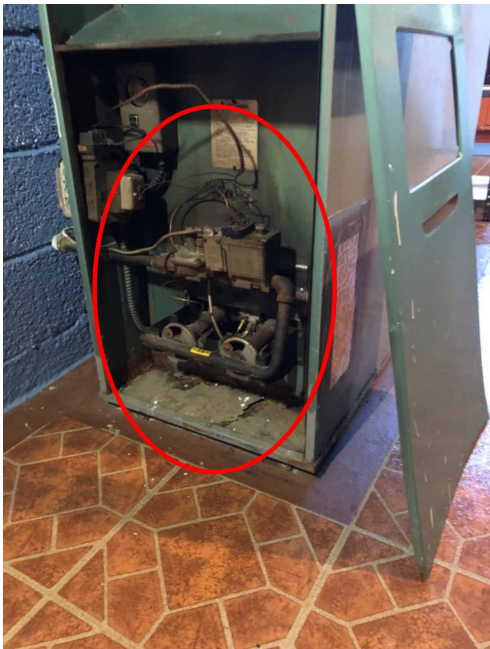
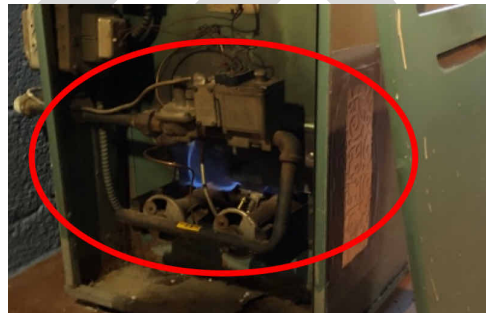
Scorched Cabinet Interior

58: The burners failed to ignite in a timely manner. This suggests low gas pressure, clogged burner ports, or insufficient pilot flame. We recommend the furnace be serviced, cleaned, and adjusted by a qualified professional.

59: The flames from the burners were witnessed to be "rolling out" into the cabinet and possibly back drafting. This needs to be fixed immediately as it is a life safety issue because combustion gases are entering the living space. We do not recommend using the furnace until it has been thoroughly examined by a qualified HVAC professional. Operation of the unit in its current condition may lead to bodily injury or death.

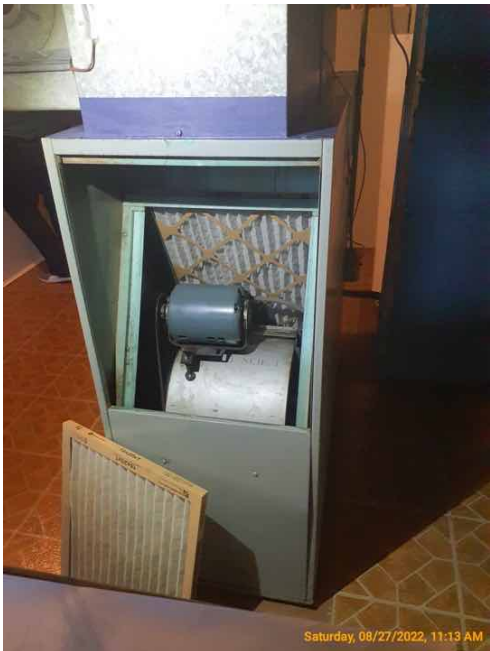
Blower/Motor

61: Dust and debris have built up on the blower and in the blower compartment. Having a dirty blower and blower compartment can shorten the lifespan of the blower motor and cause lower-than-expected air quality within the home. We recommend a qualified HVAC professional to service and clean this area.

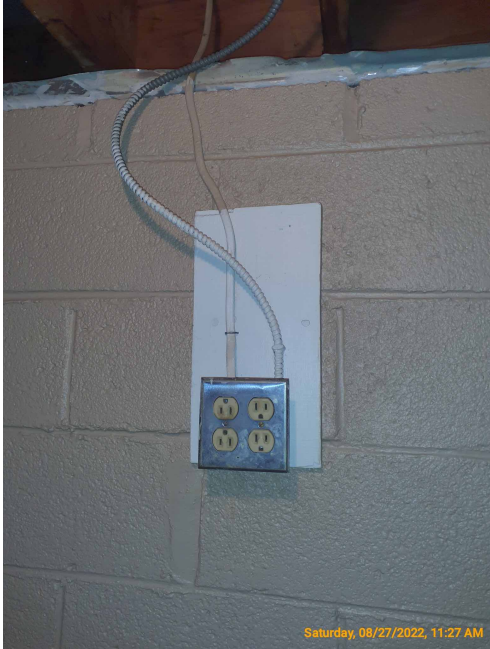
Wiring

81: Improper wiring methods have been employed. Whenever wiring is within seven feet of the floor, it needs to be protected by a conduit or armored cable. We recommend all substandard wiring be removed and approved wiring be installed by a licensed electrician.

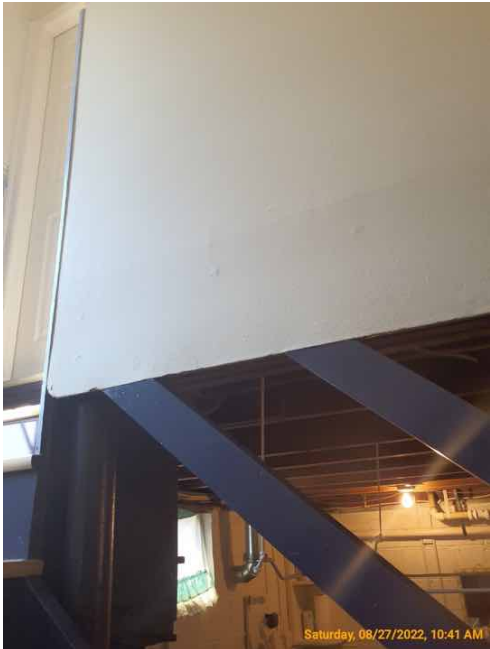
Stairs/Handrails/Railings

82: The stairs entering the basement were missing a sufficient, graspable handrail and or have an unconventionally designed handrail that is not easily held. This is a life safety issue because people expect there to be an easily held and grasped, sturdy handrail available during normal use and especially in a time of emergency. We recommend that handrails be installed by a qualified professional that meet modern building standards.

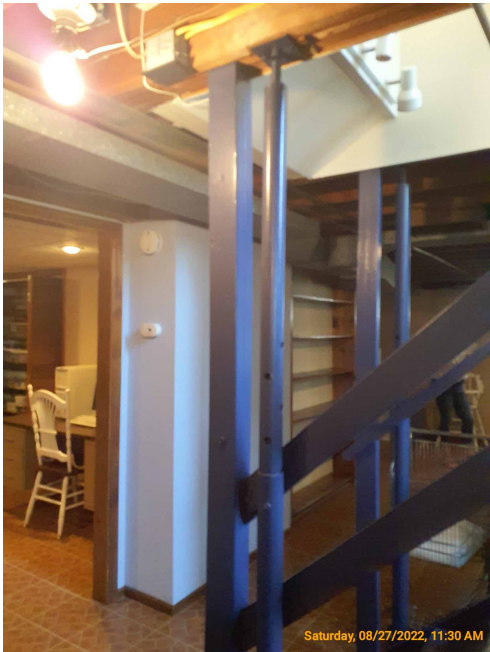
Posts

83: The floor system appeared to be supported by one more temporary post. These types of posts are not designed or intended to be used indefinitely. The posts should be replaced with permanent ones by a qualified professional.

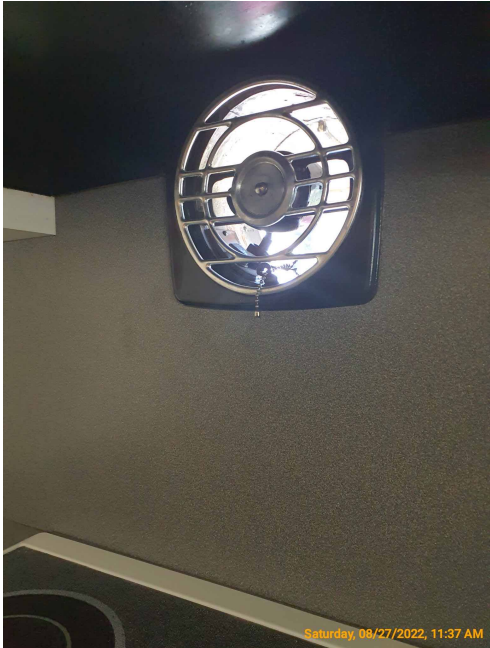
85: The ventilation in the kitchen is provided by a fan mounted in an external wall. This appeared to be functioning at the time of inspection but it was dirty. We recommended cleaning so it remains efficient and to help prolong the useful life of the fan.

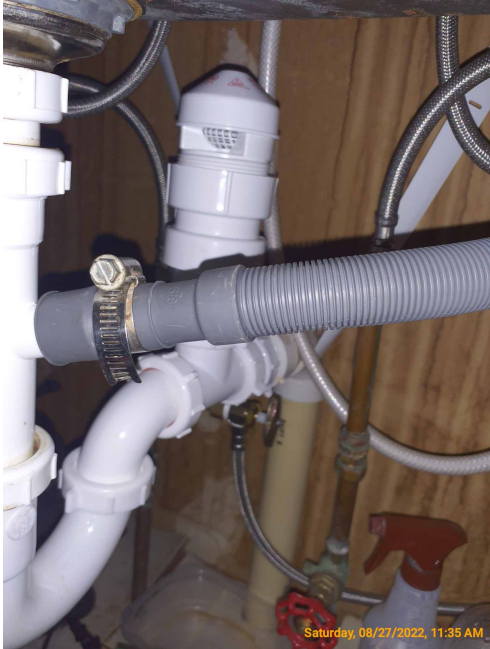
91: There was an air vent found under the kitchen sink. Typically these are installed to help facilitate drainage but they fail over time and will allow sewer gases into the home. This can be, at a minimum, a nuisance and possibly lead to health problems. This should be fixed and we recommend a licensed plumber further evaluate and recommend replacement and repair options.

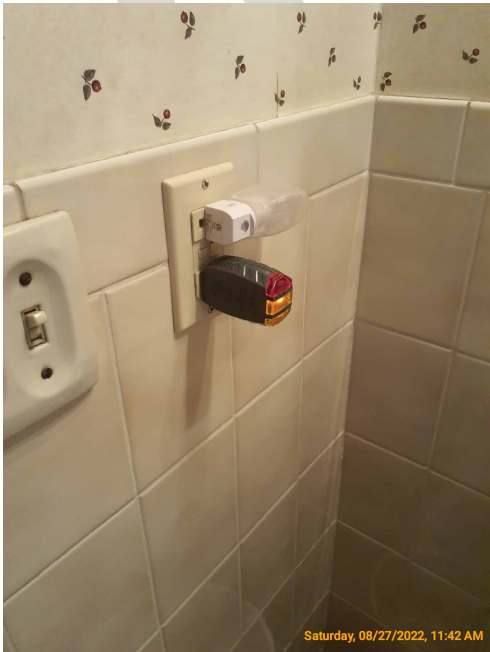
One or more of the outlets were considered to be "tired" and could present electric shock hazards. All tired outlets should be replaced by a licensed electrician.

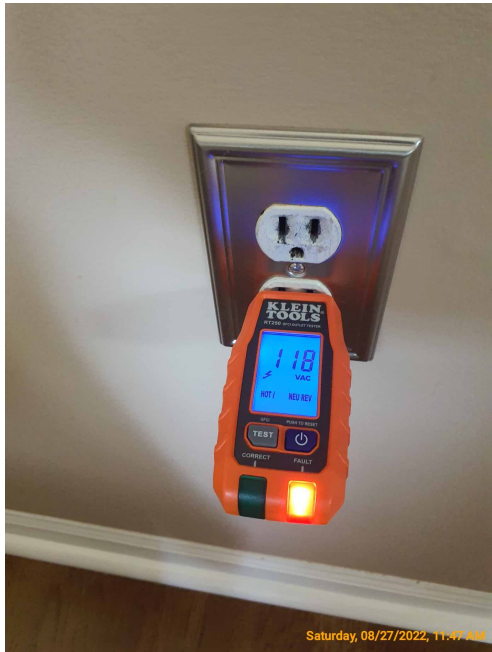
98: One or more outlets were tested and observed to have their Hot/Neutral reversed. This is a common condition sometimes referred to as reverse polarity. This creates a shock and short hazard. While the outlet(s) may still be able to provide power to your electrical items, this can damage your home, appliances, and electrical devices and may cause serious bodily harm. We recommend that a qualified electrician check for correct polarity and identify and repair all receptacles as needed.

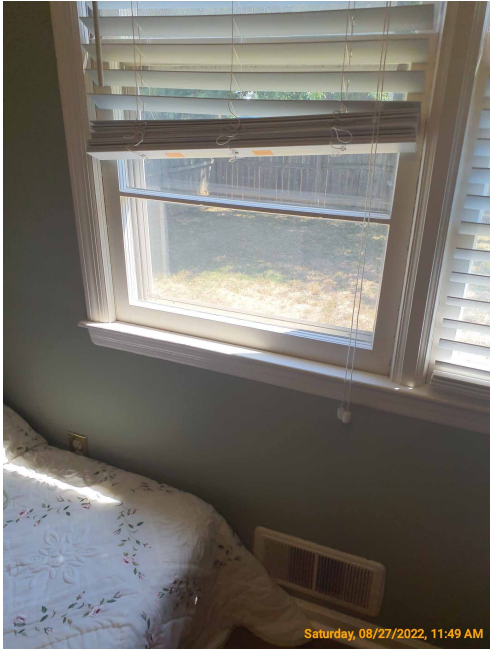
99: Windows are stuck or have been painted shut and cannot be opened. We recommend repair to restore functional use. Careful work with a razor knife may be sufficient.

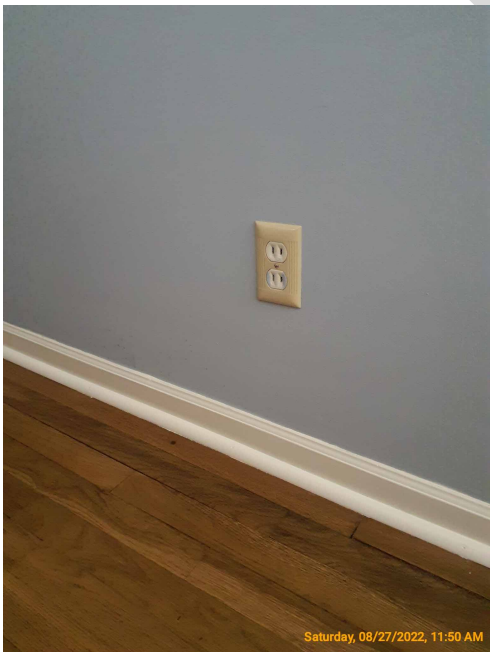
100: There was at least one older style, 2-prong, receptacle in the master bedroom. We recommend replacing it with a modern 3-prong plug. Without the third prong, there is an increased risk of shock and damage to electrical appliances if only two prongs are used.

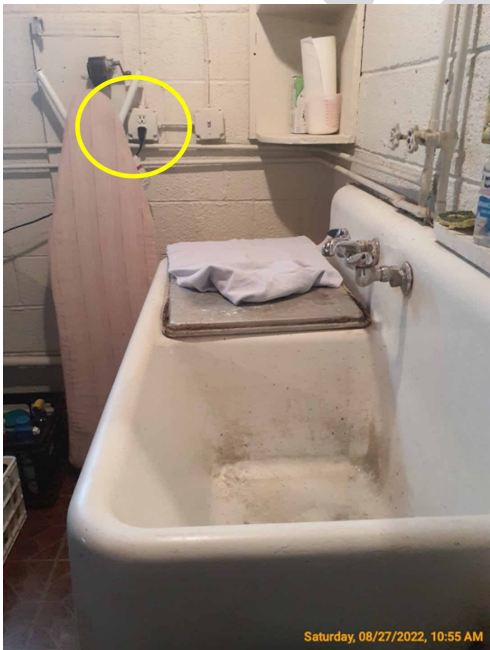
Receptacles

110: There is no GFCI (ground fault circuit interrupter) protection for this area. For an increased margin of safety, we recommend the installation of a GFCI receptacle.

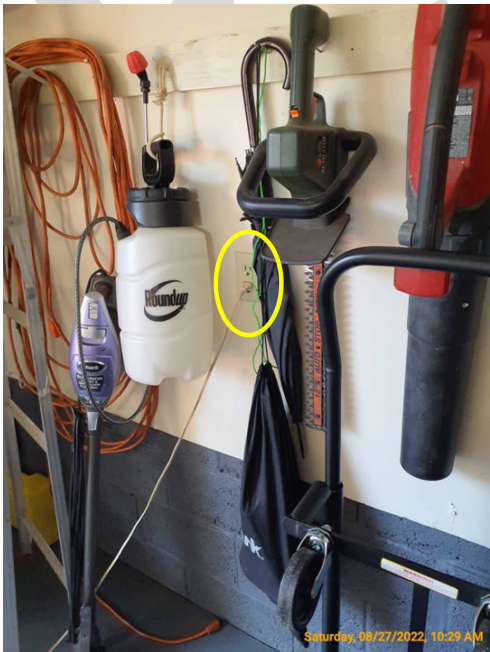
Receptacles

115: There was no GFCI (ground fault circuit interrupter) protection for this area. For an increased margin of safety, we recommend the installation of a GFCI receptacle by a licensed electrician.

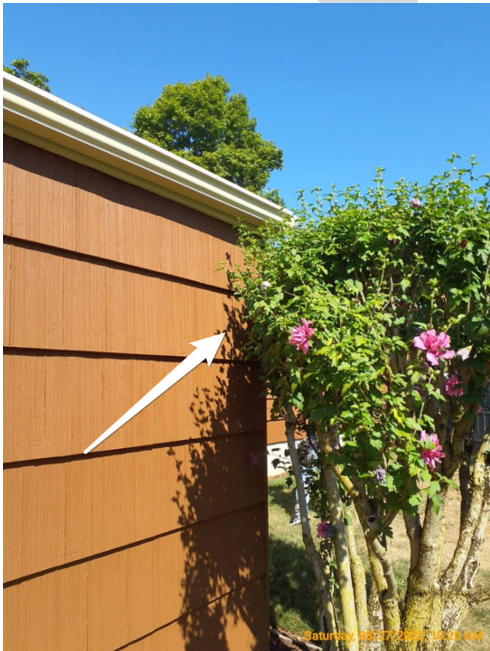
s-14: We recommend the vegetation on the property be maintained to prevent overgrowth and encroachment onto and over the structure. When vegetation is in contact with or too close to a structure, pests and moisture can quickly enter. It also limits the ability of the structure to effectively dry after rain. Structures that remain moist for prolonged amounts of time can have problems with rot, mold-like substances, and wood-destroying insects.

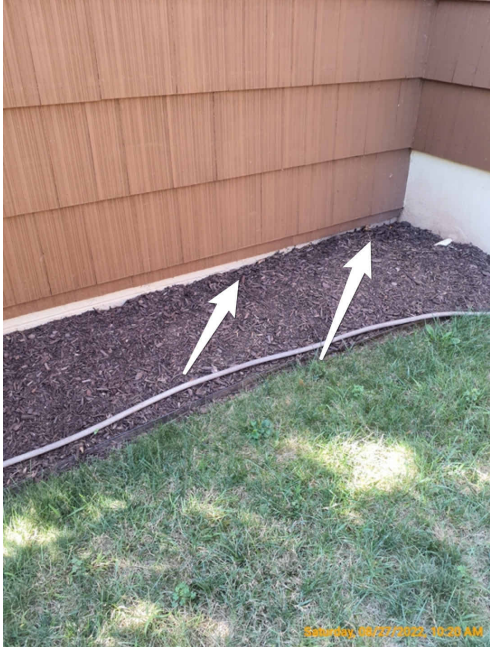
Exterior/Site/Ground Wood Siding

s-15: There is potential earth-to-wood contact in one or more areas, which makes the siding vulnerable to deterioration. We recommend all earth-to-wood and near-earth-to-wood contacts be broken to prevent moisture or pest-related damage. It is recommended to have at least 8 inches of space between the wood siding and the earth to prevent moisture intrusion. This work should be performed by a qualified professional.
