Confidential Home Inspection Report

123 Main St
Tinton Falls, New Jersey 07724

Inspection Date:
Thursday, February 16, 2023

Prepared By:
Cole DeAngelis from Home Run Inspection Services

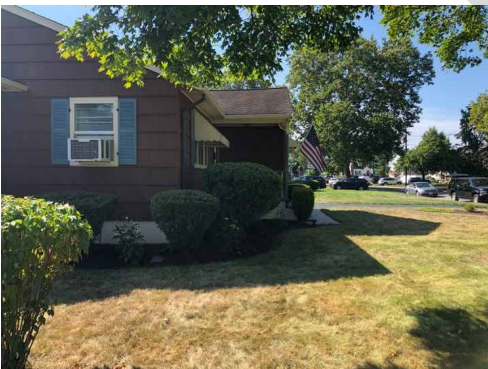
17: The grading of the lot appears to properly and adequately drain excess surface water and roof runoff away from the structure.

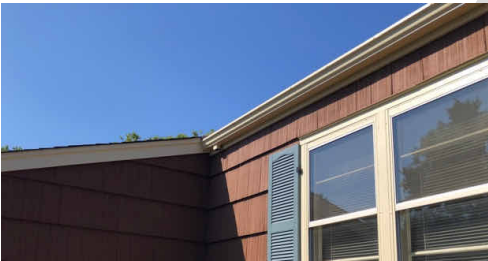
32: Roof runoff water is channeled to the downspouts by a metal gutter system attached to the fascia boards or to the ends of the rafters along the edge of the roof.

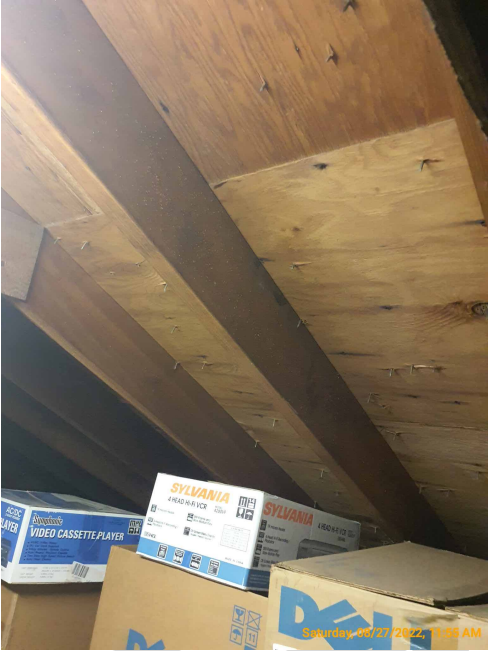
38: The roof sheathing is plywood nailed solidly across the rafters.

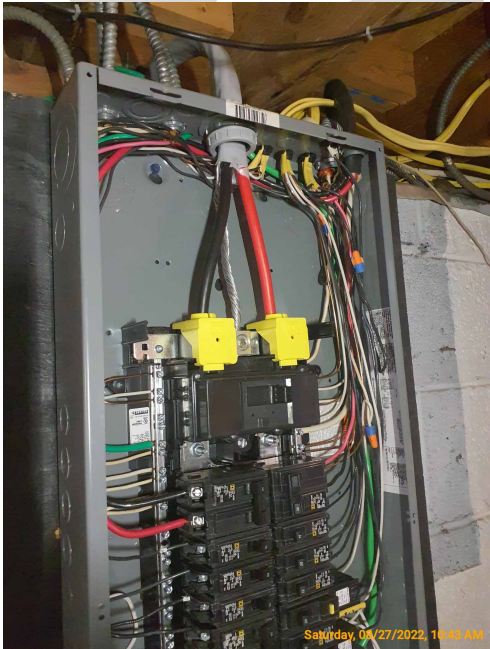
41: The Main Service entry material appeared to be Aluminum.

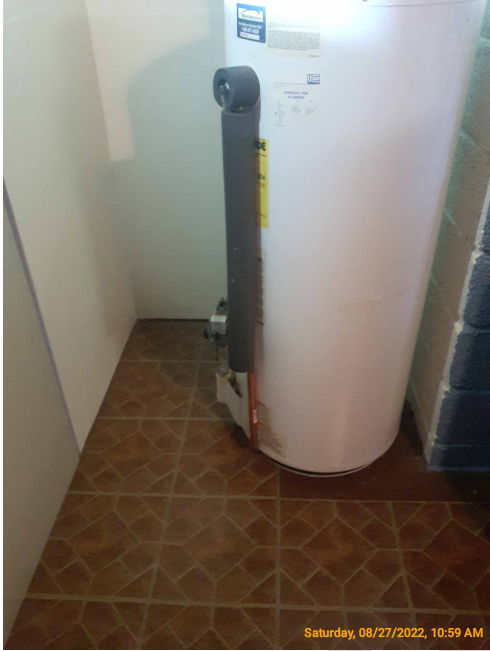
51: The water heater was equipped with a temperature and pressure relief valve. This device is an important safety device and should not be altered or tampered with. Although the device appeared to be in working condition with no adverse observations made, it is outside the scope of a home inspection to operate safety valves so it was not tested.

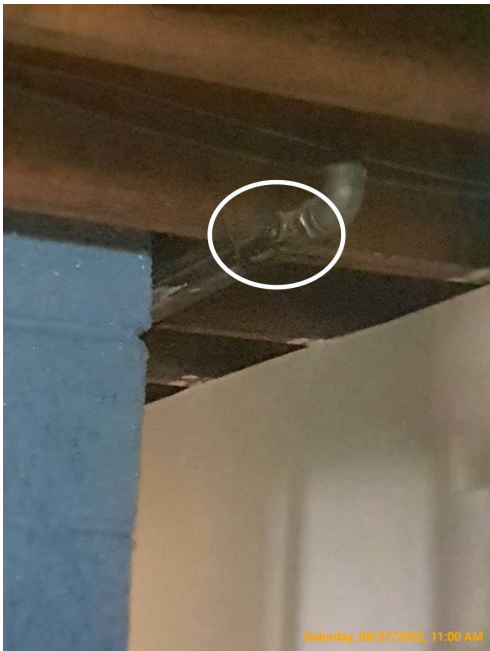
52: The gas piping for the water heater appeared to include a local shut-off valve for use in an emergency or case of repair. It is outside the scope of a home inspection to operate safety valves so it was not tested.

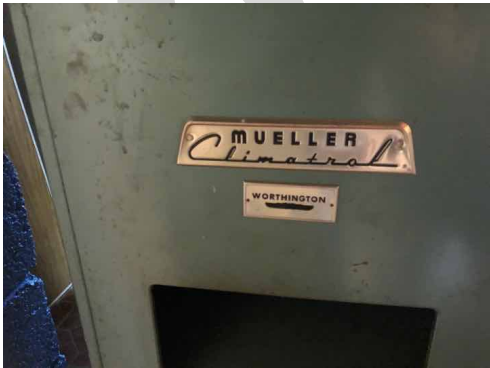
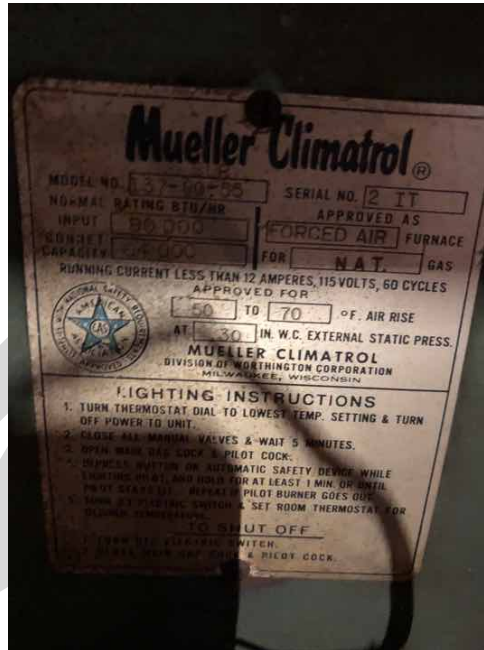
54: Age: We were unable to determine the exact age but the overall appearance of the unit leads us to believe that it may be near the end of its expected life and that it is over 20 years old.

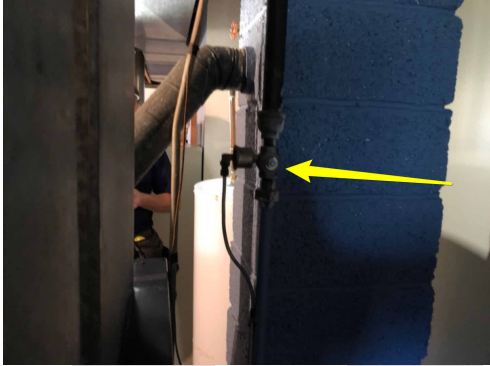
57: The gas piping appeared to have a shutoff valve. It is important to keep access available to this valve in case of emergency. It is outside the scope of a home inspection to test safety valves so it was not tested. However, periodical manipulation of the valve can help to prolong its useful life and help to ensure its proper operation in times of emergency. We recommend a qualified HVAC professional be hired to test the valve, and inspect the entire system, due to other issues identified and the overall age and appearance of the heating system. This will help to limit the chances of fire or other risks related to old or defective equipment being used.

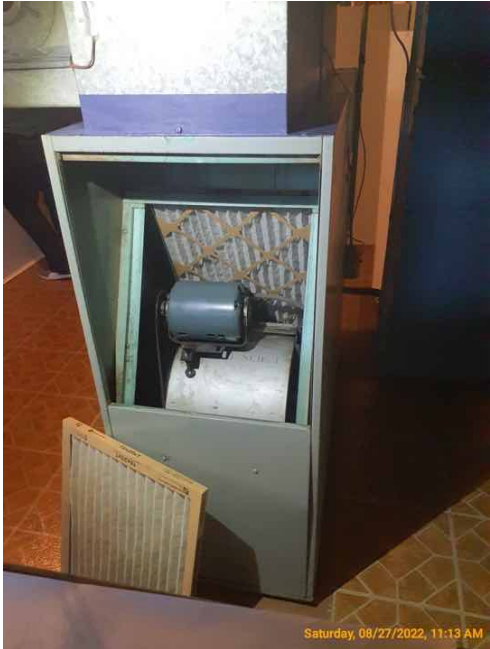
60: The air filter for the heating unit present during the inspection was a conventional, disposable filter measuring 16x20x1. This particular unit uses two air filters but special precautions should be taken when replacing it since the blower motor and some of its moving parts are also accessible within the air filter compartment. If someone were to come into contact with any moving motor parts while replacing one or both filters, some type of bodily injury would most likely result.

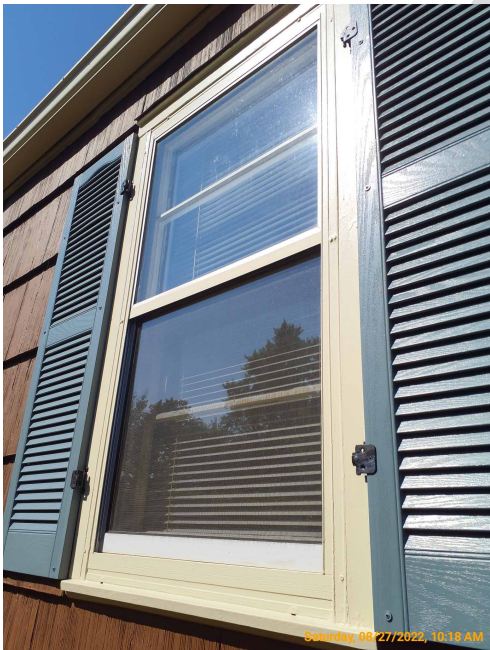
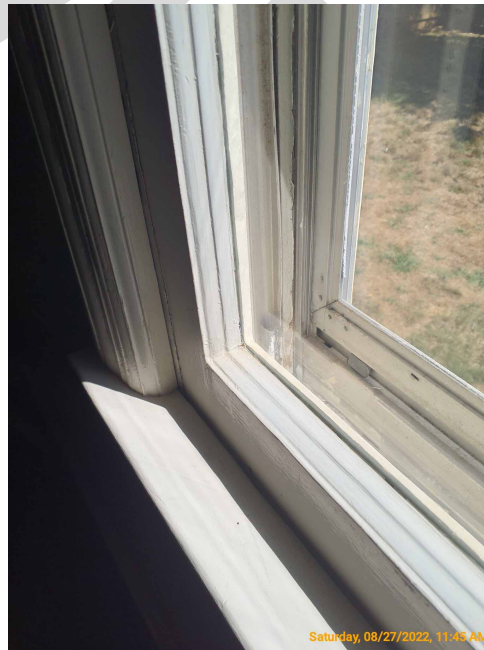
66: During the home inspection, the inspector attempted to observe and inspect a representative number of windows. Most of the windows observed and/or inspected were single-glazed. However, there may have been other windows with different variations of glazing present during the inspection. Since it is impossible to inspect every window, the Standards of Practice only require a representative number to be inspected.

****We highly recommend consulting the appropriate qualified professional(s) before starting any project(s). Replacing any windows in a home can be a large financial investment and the limited scope of this home inspection and the resulting report should not be solely relied upon when making such a decision.**

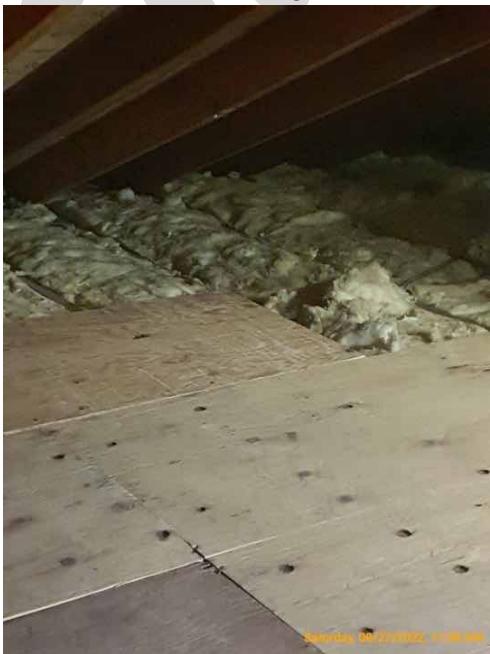
70: The attic had fiberglass batt insulation that appeared aged but still in functional condition.

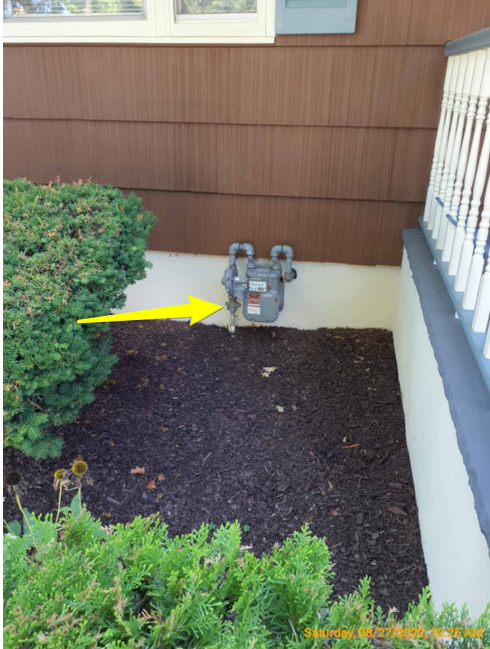
74: The gas shut-off valve was located on the outside adjacent to the front steps. It is important that clear access to the valve is maintained at all times and that the valve is periodically manipulated. This will improve the likelihood that the valve is functional in time of an emergency.

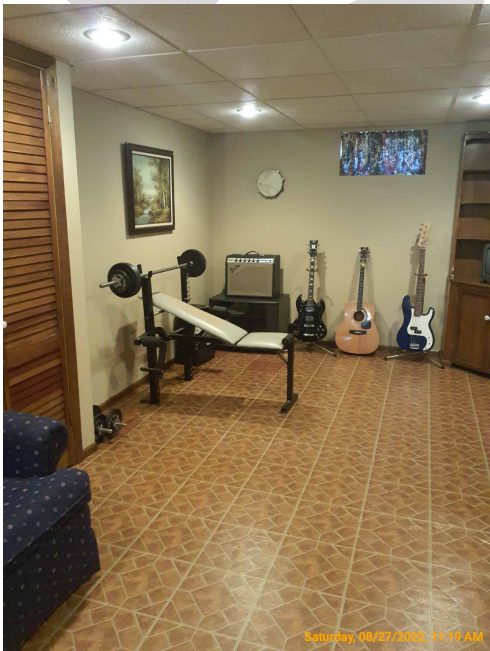
77: The basement was at least partially finished. This limited the inspector's ability to visually inspect all or portions of the basement. Basements inevitably get wet to some degree during their existence but with the limitations present the inspector was unable to find signs of moisture presence. However, hidden evidence of current or previous moisture damage/presence may exist even though the inspector was unable to locate it during the time of the inspection. The basement, foundation, basement walls, floors, and other areas were not inspected and are therefore disclaimed. It is recommended to have all hidden areas further examined by a qualified professional.

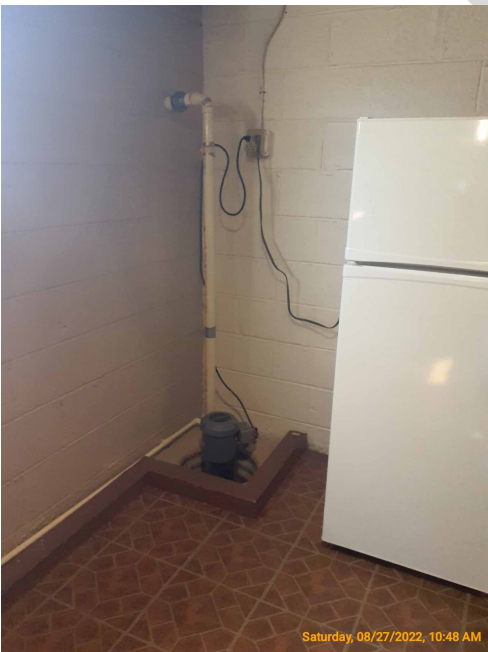
80: A sump pump was observed at the time of the inspection and they are usually installed to remove occasional water from the sump. The pump was not tested under normal working conditions.

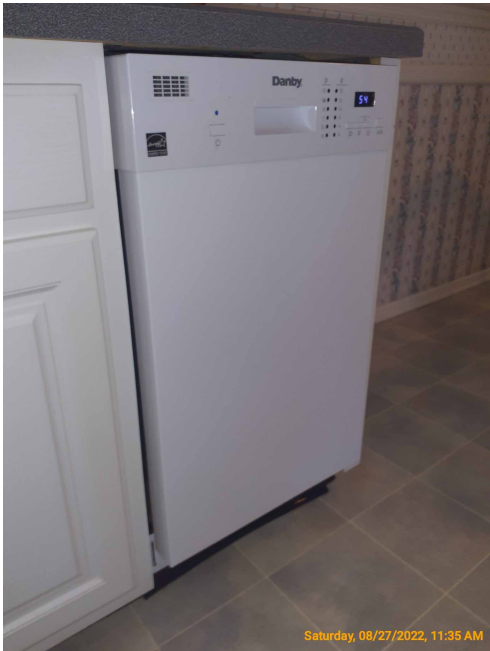
87: The dishwasher responded to normal user controls and was found in good condition.

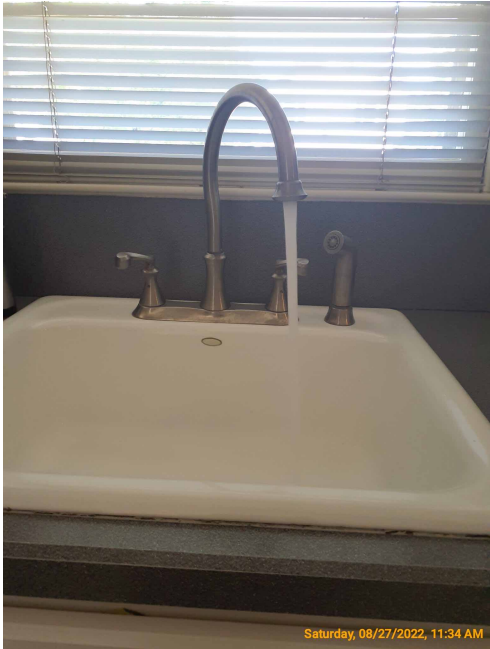
Sink

89: The sink appears to be properly installed. When operated, it was observed to be fully functional and in serviceable condition.

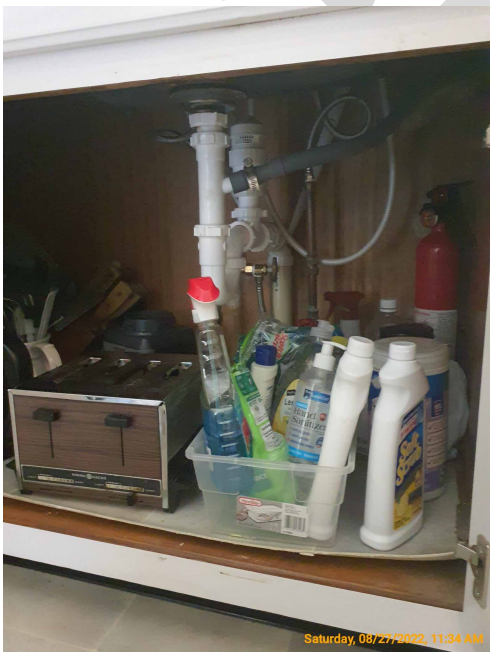
Drain Traps

90: The drain trap was inaccessible due to storage of personal property.

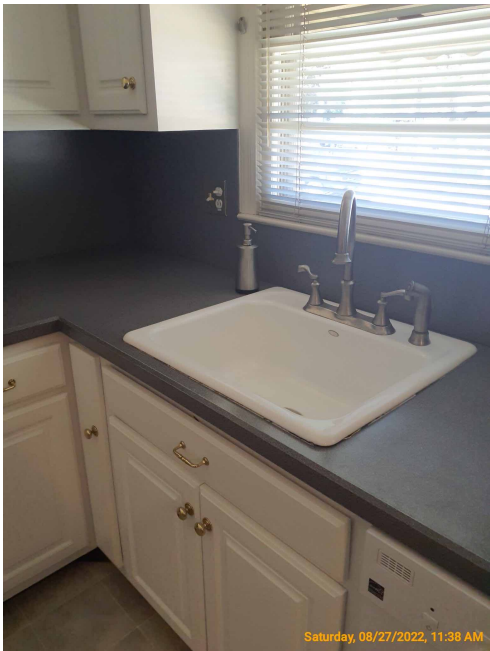
92: GFCI (ground fault circuit interrupter) protection is intended to provide an increased margin of safety. GFCI protection was observed at one or more of the outlets at the time of the inspection. We recommend testing these devices on a monthly basis to ensure they're operating properly.

Trips in basement.

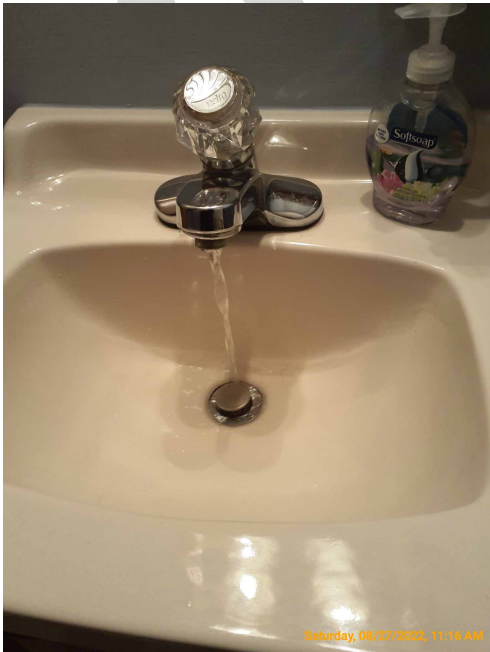
Sink

93: The sink was tested and appeared to function properly during the inspection. A properly functioning sink is a necessity for the proper hygiene of the inhabitants.

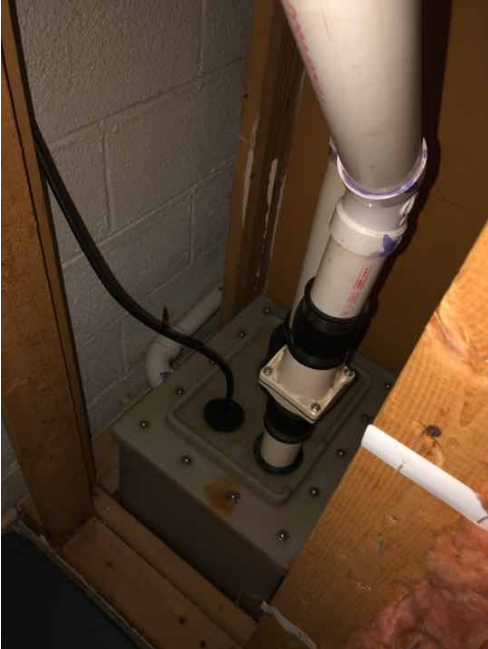
Toilet

94: The toilet was flushed and appeared to be functioning properly. There was what is believed to be a sewage ejector pump installed in the downstairs bathroom and it appeared to function properly when used under normal circumstances.

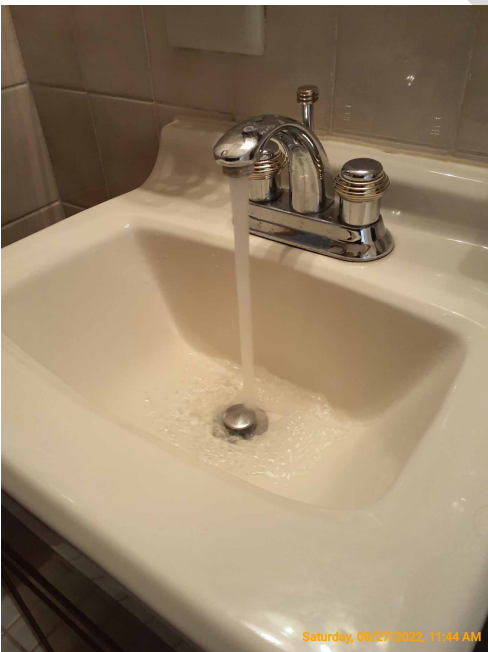
Sink

95: The sink was tested and appeared to function properly during the inspection. A properly functioning sink is a necessity for the proper hygiene of the inhabitants.

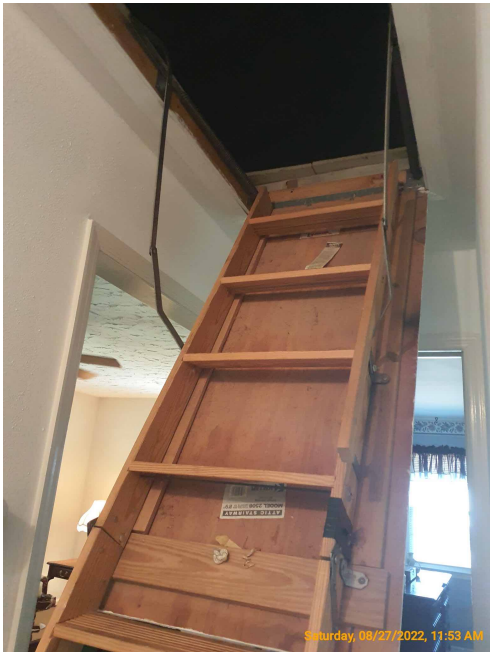
Access/Entry

101: The attic access was located in the hall.

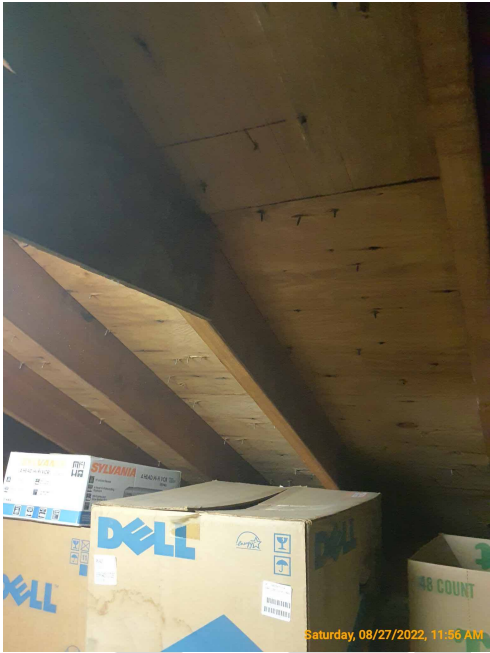
104: The roof sheathing is the material directly supporting the roof covering.

105: The roof sheathing is plywood nailed solidly across the rafters.

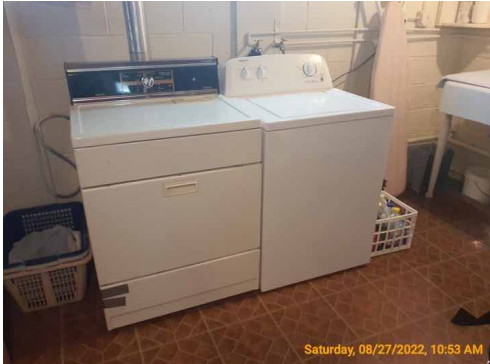
Washer/Dryer

107: There was an electric dryer at the time of the inspection.

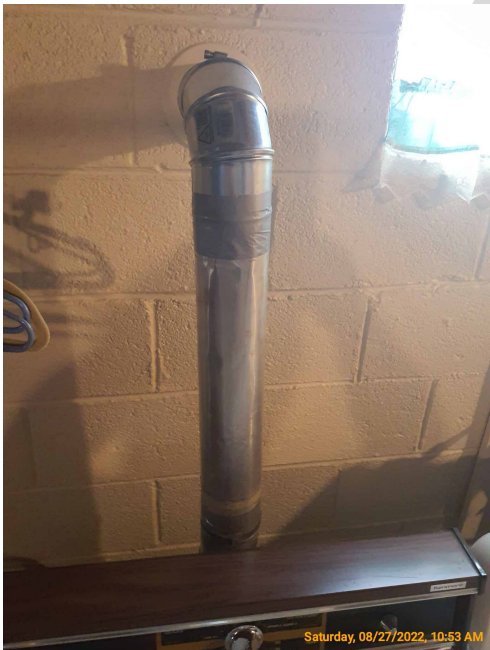
Dryer Vent

108: The dryer vent appeared to be properly installed and in serviceable condition. It is outside the scope of a home inspection to inspect the inside of a dryer vent. However, it is very important to maintain a clean dryer vent to avoid fire risks. During the inspection, portions of or all of the dryer vent were inaccessible and were not inspected and the vent in its entirety is therefore disclaimed. Inspecting the dryer vent regularly is recommended to ensure it is not crushed and is clear of any debris.

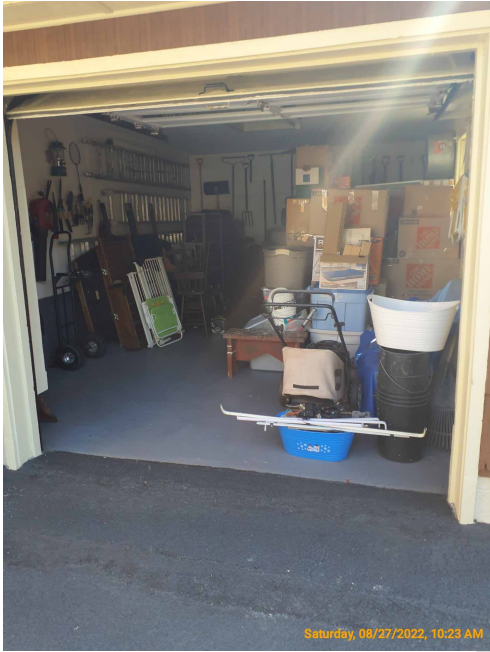
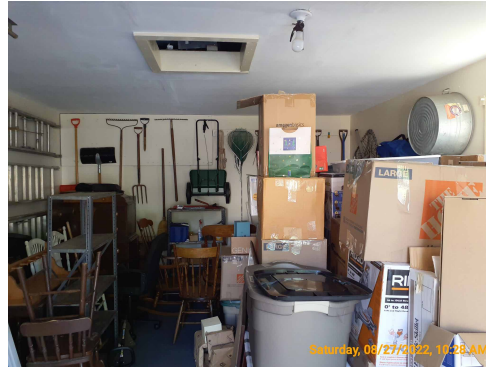
Limitations

111: There were one or more areas of the garage which were occupied by personal belongings. This limited the inspectors ability to visually inspect some or all of the garage. It is recommended to have the area inspected once it is clear of all belongings and all areas are fully accessible for examination. This area is disclaimed.

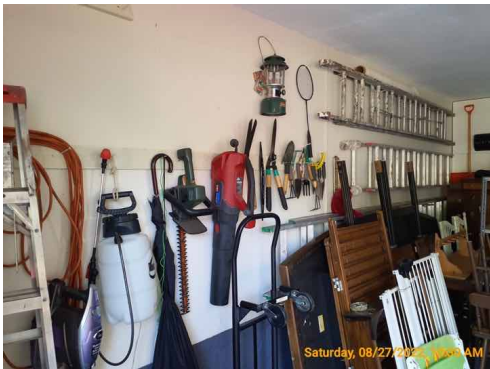
Fire Separation

112: The wall between the garage and the living space is of fire resistive construction as required by today's building standards.

113: The fire separation wall between the garage and the living space is without problems where visible. However, portions of the wall could not be inspected and are therefore disclaimed. Once there is access, we recommend this wall be checked for any penetrations, and that it be patched if necessary.

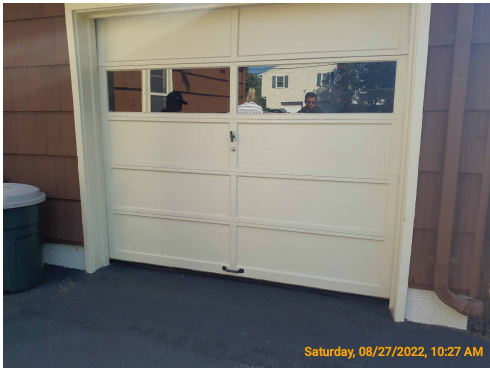
Garage Doors

114: The garage door is a single roll up design.

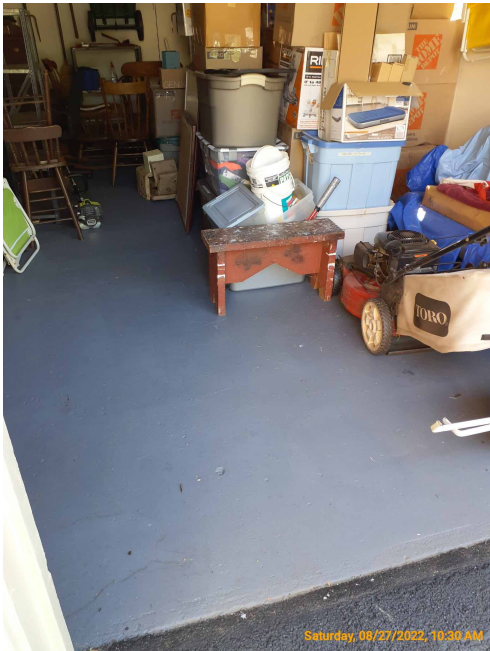
Floor

118: Where it was visible, the floor looked to be a concrete slab.

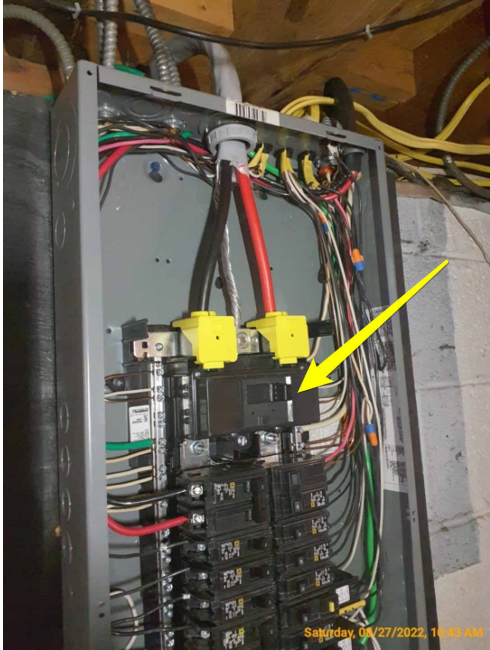
1: The main disconnect is incorporated into the electrical service panel.

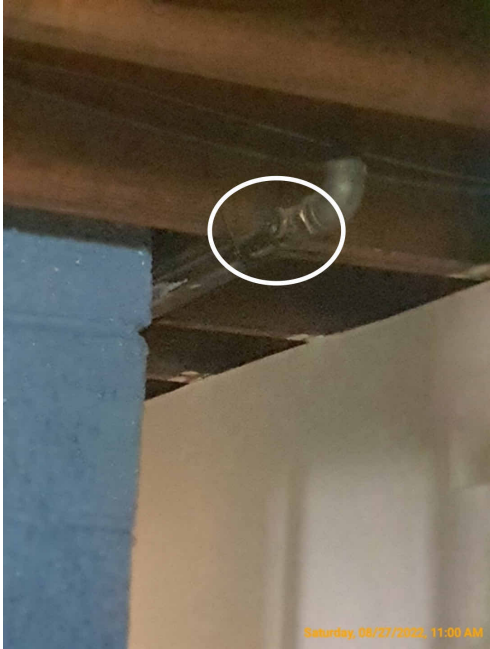
2: The gas piping for the water heater appeared to include a local shut-off valve for use in an emergency or case of repair. It is outside the scope of a home inspection to operate safety valves so it was not tested.

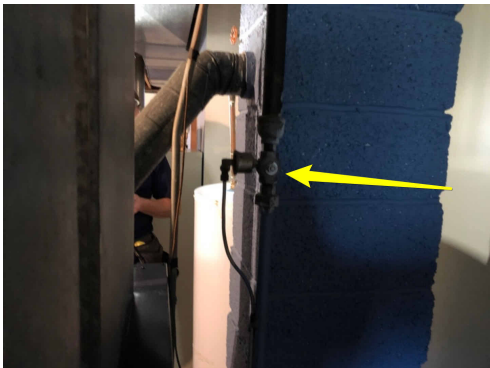
3: The gas piping appeared to have a shutoff valve. It is important to keep access available to this valve in case of emergency. It is outside the scope of a home inspection to test safety valves so it was not tested. However, periodical manipulation of the valve can help to prolong its useful life and help to ensure its proper operation in times of emergency. We recommend a qualified HVAC professional be hired to test the valve, and inspect the entire system, due to other issues identified and the overall age and appearance of the heating system. This will help to limit the chances of fire or other risks related to old or defective equipment being used.

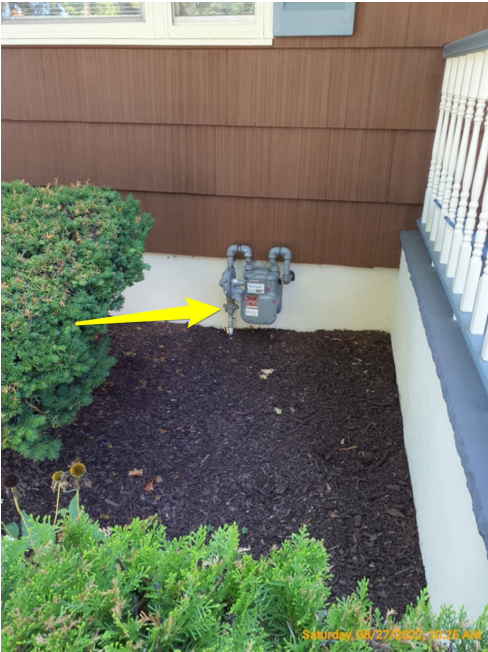
4: The gas shut-off valve was located on the outside adjacent to the front steps. It is important that clear access to the valve is maintained at all times and that the valve is periodically manipulated. This will improve the likelihood that the valve is functional in time of an emergency.

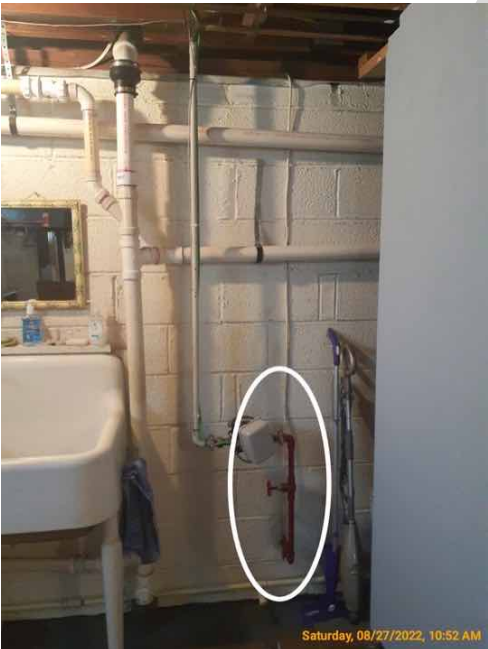
5: The domestic water supply main shut-off valve is located in the basement.

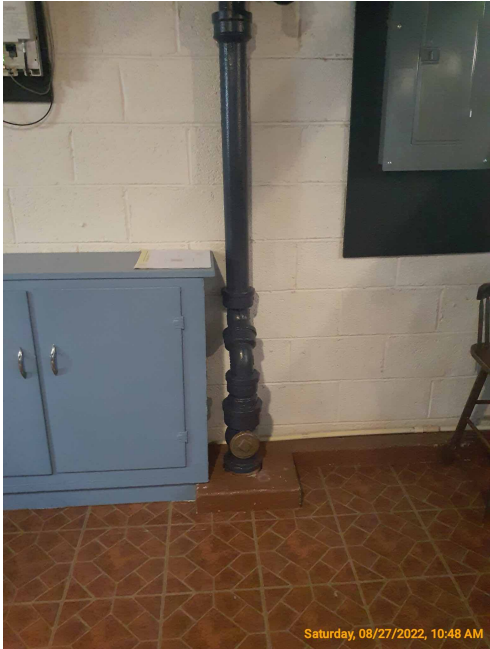
6: The sewer cleanout is located in the basement.

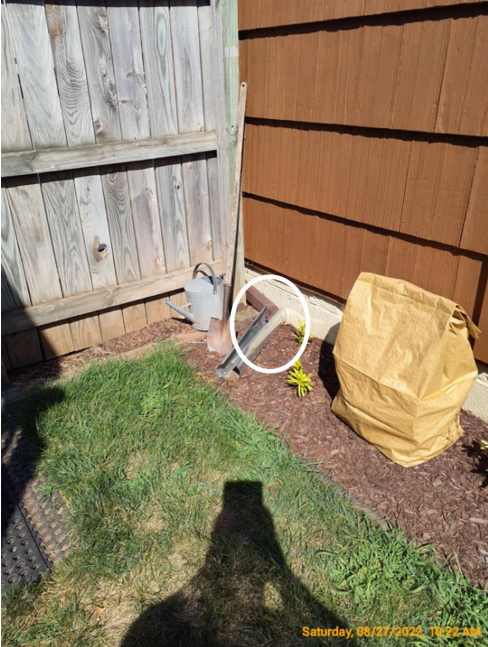
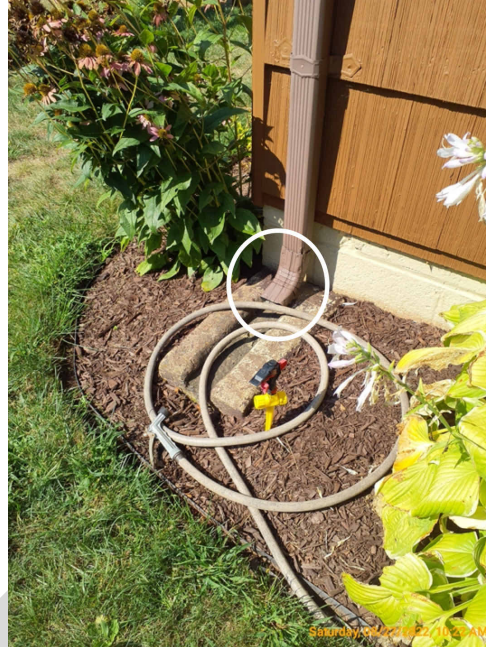
Exterior/Site/Ground Downspouts

s-16: Runoff water from the roof appeared to discharge too close to the house in one or more areas. We recommend the downspouts discharge at least six feet away from the structure to prevent puddling, pooling, and over-saturation of the soil. If water discharges within six of a foundation it can cause structural damage, it can lead to a wet basement, and other issues. This should be corrected to avoid potentially costly damages.

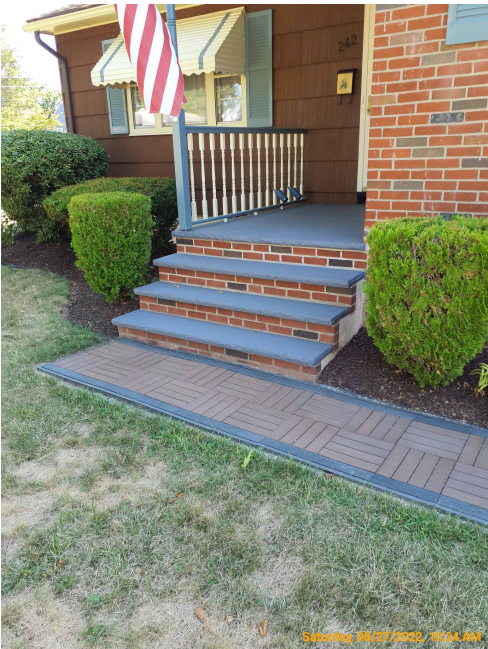
Exterior/Site/Ground Railings

s-18: There are no hand railings at the front steps. As a safety measure, we recommend that railings be installed by a qualified professional. Without a sturdy railing to grasp in an emergency, a person could suffer bodily injury in the event of a fall or stumble.

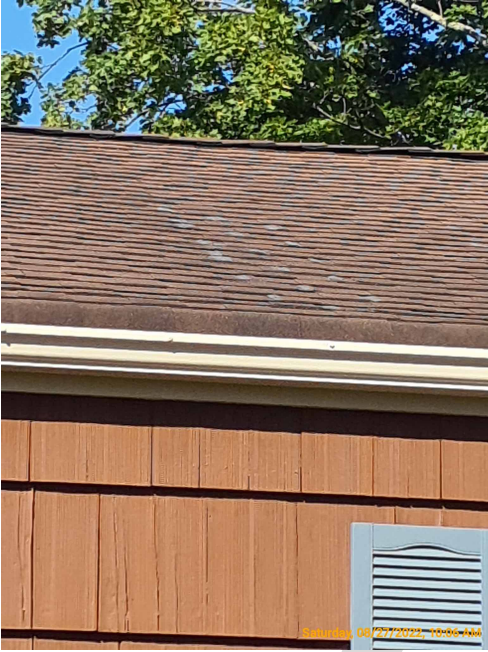
Composition Shingle Roofing Surface

s-29: Portions of the surface granulation have deteriorated and there are areas of discoloration developing. These are signs of aging and the roof should be monitored to see if there is action warranted in the future to correct any problems. At the time of inspection, the roof covering did appear to be functioning even though there were signs of obvious aging.

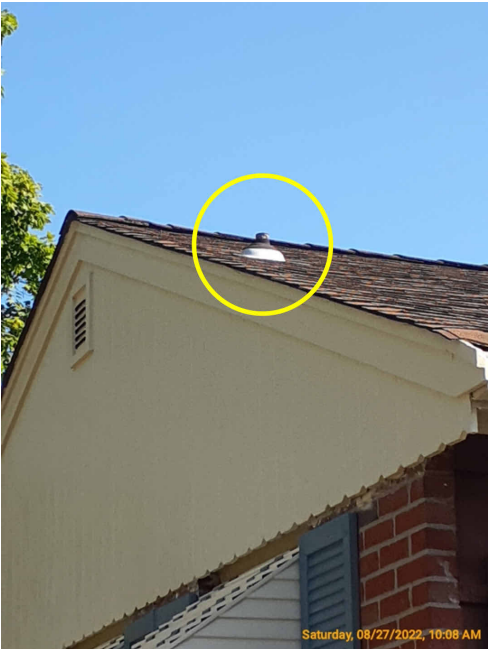
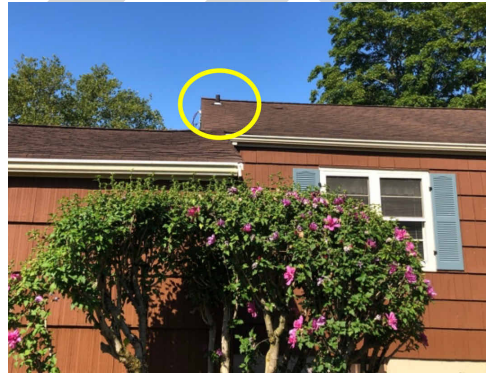
Composition Shingle Roofing Plumbing Vents

s-31: One or more of the plumbing vents is shorter than required by present standards. Poorly vented drain/sewer lines will not be able to effectively move wastewater and solids out. In our opinion, adverse conditions such as overflowing drains, backed-up toilets, and similar plumbing issues may result from this configuration. We recommend a qualified professional be hired to update to modern building standards.
